# 2005 Ventura River and San Antonio Creek Watershed Sanitary Survey Update

### **Ventura River/San Antonio Creek Watershed Sanitary Survey 2005 Update 31 March 2006**

#### **City of San Buenaventura**

K/J Project No. 0589056

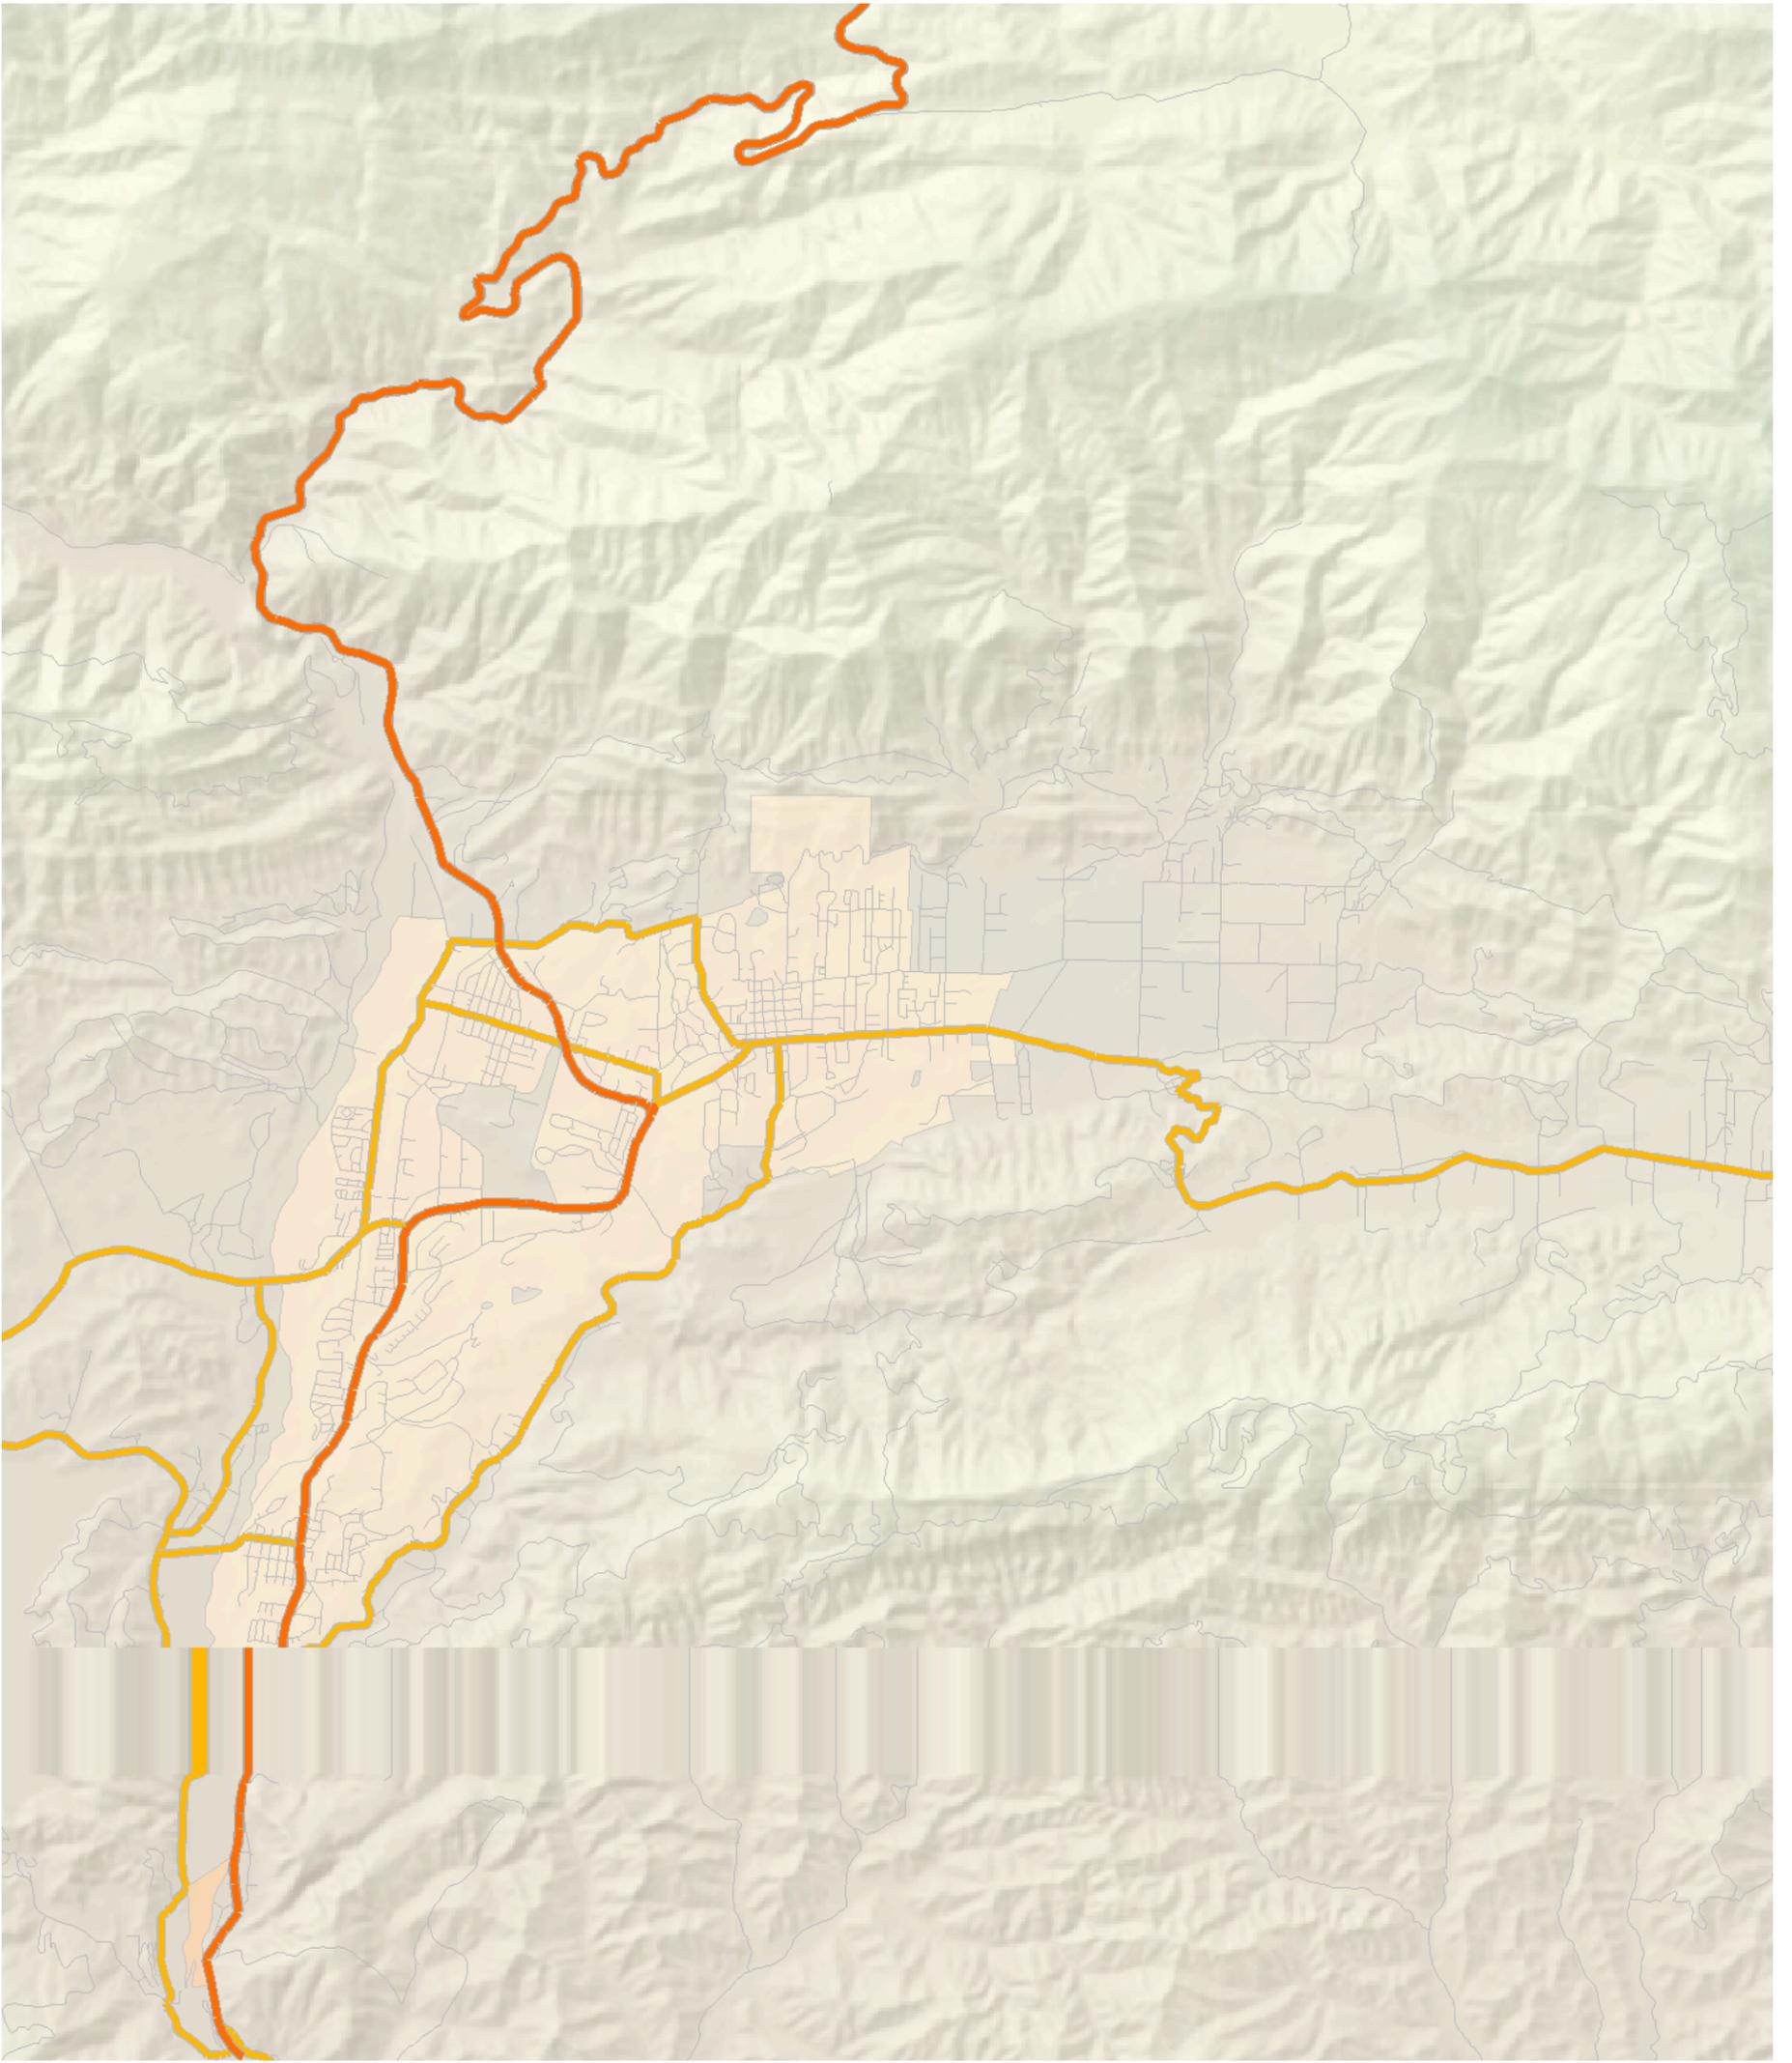
OVSD is the governing agency for domestic wastewater collection, treatment, and disposal within the watershed. The OVSD service area has remained essentially unchanged since 2000 and is shown in Figure 7. OVSD's wastewater treatment plant provides tertiary level treatment with nutrient reduction treatment facilities. The OVSD WWTP location and discharge point

Four of OVSD's six lift stations are located within the study area. Their locations are shown on Figure 7. The pump stations are monitored 24 hours a day via a radio-based telemetry system connected directly into the OVSD Treatment Plant SCADA system. By the spring of 1999, OVSD had installed its DCS telemetry system at its facilities throughout the District. This telemetry system transmits up to the minute operational information, flows, and alarms to the treatment plant's SCADA system. The SCADA system is equipped with a call out system that receives alarms and automatically contacts standby personnel during off-hours.

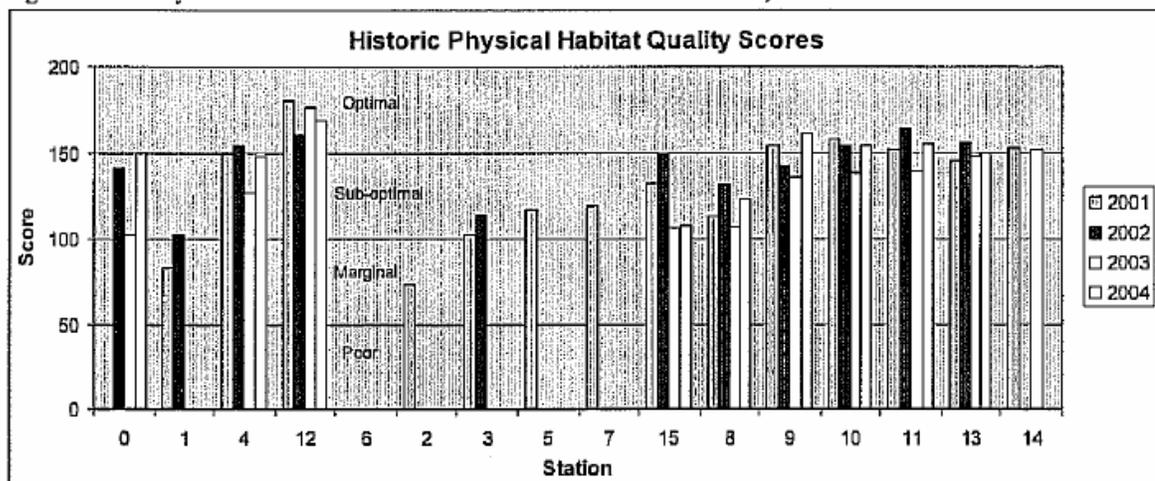
**Figure 9-10: Physical habitat scores for sites in the Ventura Watershed, 2001 to 2004**

Figures 9-10, 9-11, and 9-12 are extracted from the report and shown below. They indicate that the SD IBI consistently ranked sites in the watershed as either good or very good, while the So CA IBI ranked the same sites as poor or fair. In addition, the best physical habitat conditions can be found on the main stem of the Ventura River, upper San Antonio Creek and Matilija Creek, while the worst habitat conditions can be found on San Antonio Creek and Stewart Canyon Creek.

The report concludes that the types and abundances of species found throughout the watershed during the four year period changed very little. Most of the changes were subtle shifts in the relative abundances of groups of species that were common throughout the watershed. These results indicated that water quality in the watershed remained relatively stable during this four year period.
